Steam turbines service and solutions to reduce unavailability, improve flexibility and extend unit life

Gabriele Porta, Luca Corso and Marco Cioffi

In recent years the radical change in market demand introduced new challenges to steam turbines maintenance activities. The last experiences gained during inspections, with the operating statistics of individual components, have allowed to take steps forward in developments both in terms of components design and calculation of Equivalent Operating Hours (e.g., taking into account the contribution due to thermo-mechanical fatigue). The objective is to keep the aging of individual components under control, plan the preventive necessary actions to be done and meet new operational needs.

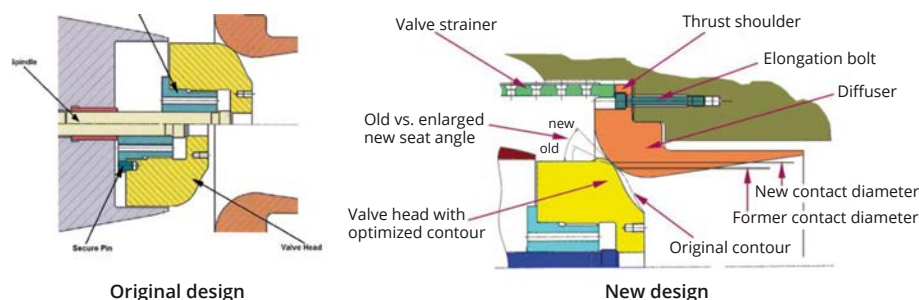
Fig. 1. HP SV upgrade.

Operational experience has shown that, under certain conditions, the stop valve type HSSV can stick in closed position. This behaviour is typical during hot start-ups: when this occurs, start up of steam turbine is delayed due to valve head-to-seat sticking. In some cases the seat pulling out has been experienced with consequent extended valve unavailability.

According to Ansaldo Energia's experience, an upgraded design has been developed to prevent stop valve head sticking as well as diffuser displacement.

Main modifications are (see Figure 1):

- bolted seat instead of thermal shrink fit assembly;
- diffuser axial fixing due to valve strainer;
- seat angle modification on valve head;
- prestroke guide bushing modification.

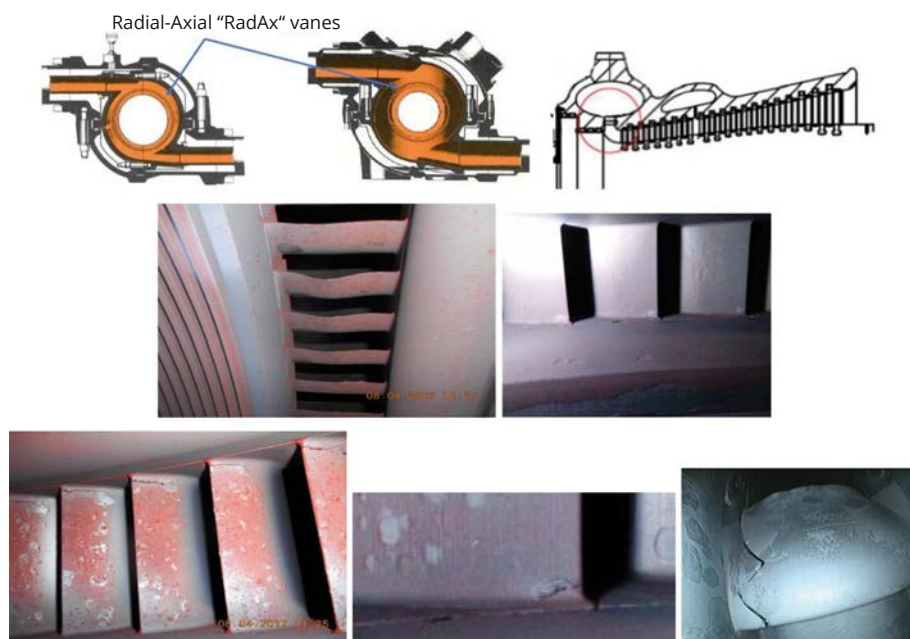
Fig. 3. Radax vanes identification and typical findings

first stationary rows (the so called RADial AXial – and so Radax – stationary rows) suffer for bending and cracking, resulting from a combination of effects, like hindered thermal expansion, exposure to high temperature and heavy cycling.

Besides crack like indications in the transition area between blade airfoil and shroud or root, bending and deformation of airfoil or shroud as well as ruptured vanes have been observed.

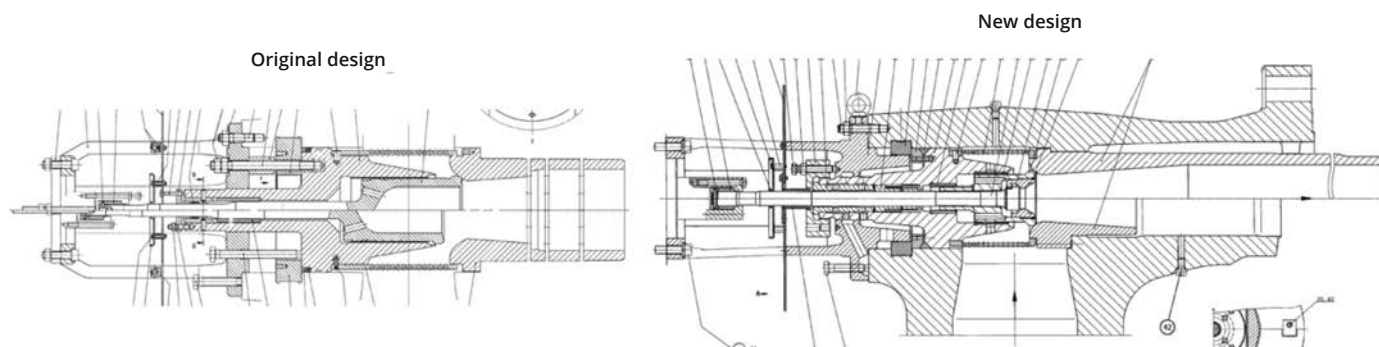
Fig. 2. HP CV upgrade.

Return of experience from sites identified the High Pressure Control Valves (HP CV) as the critical component in terms of maintenance interval limitation.

To overcome the problems related to extended time on heavy throttling, Ansaldo Energia developed new design of valve internals (see Figure 2). The design of these new internals is derived from a heavy-duty design used for large fossil power plants.

In the new design, the spindle and valve head are no longer a single piece, but an assembly with a pilot and main stroke. Two hard-faced guide sleeves support the valve head for improved stability. Pilot valve assures a better and stable operation at low load. The leak tight pilot and main stroke eliminate the need for piston rings, resulting in reduced wear during throttling operation. The improved valve head stability, combined with the pilot stroke, significantly improves throttling capability compared to the original design. Moreover, the valves seal rings will be metallic and no more in soft

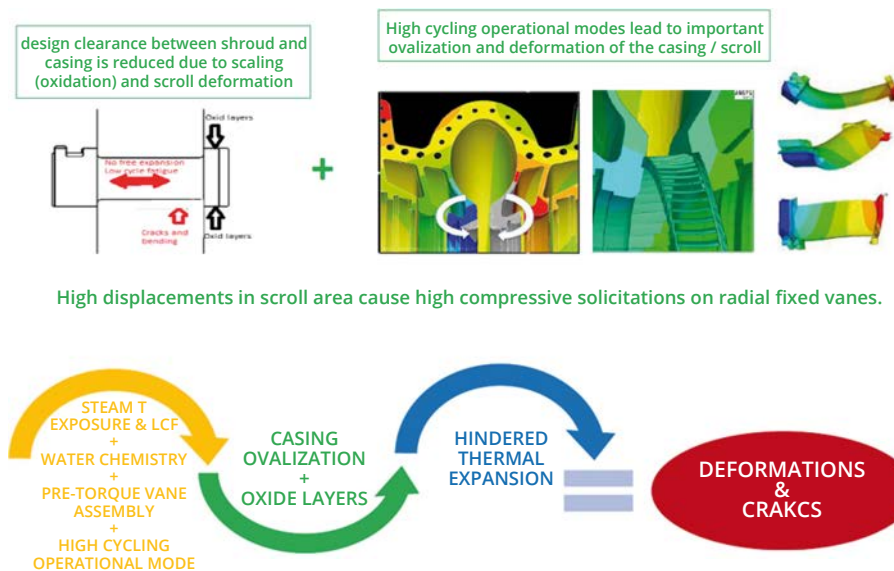
Fig. 4. Radax vanes damage mechanism.

Root Cause Analysis (RCA) suggests that steam temperature, exposure time, operation mode (connected to the casing ovalisation) and water chemistry are the main contributors. According to Ansaldo's experience, the most likely root cause of the above mentioned findings and potential cracking is Low Cycle Fatigue (LCF) damage, due to additionally introduced thermo-mechanical load. This can happen, when the gap be-

tween shroud and casing is closed due to scaling and the casing deformation, so the blade shroud is strongly clamped into the casing groove. The build-up of oxide layers strongly depends on the steam temperature over its exposure time and also on the water chemistry.

In Figure 4 Radax vanes damage mechanism is shown.

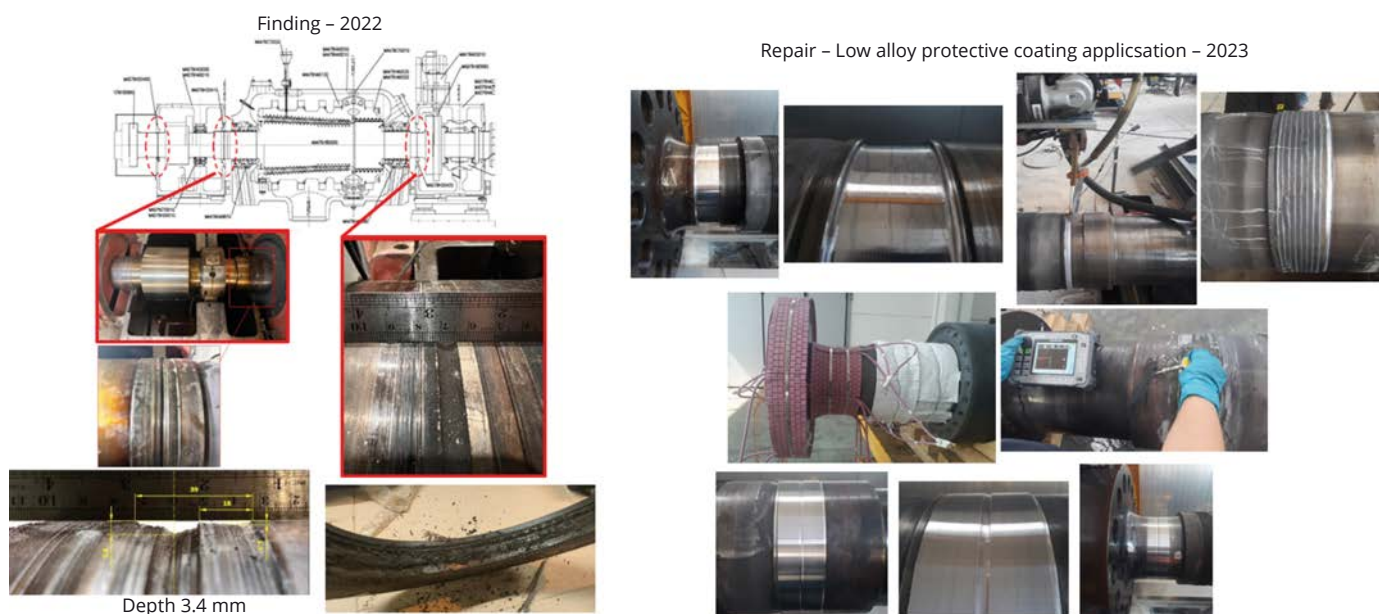
Fig. 6. Wire wooling damage on rotor oil baffles area, online repair case study.

As a reference, a relevant case study was selected, related to a 130 MW MT15 reaction type turbine (2 cylinders unit) manufactured by Ansaldo Energia. A wire wooling at medium stage was detected on all the HP rotor oil baffles working area as it is possible to see in the Figure 6 (pedestal number 1 and number 2), during an unplanned outage in 2022. Cracked oil and carbrides residues are very clear on the oil baffle. The maximum depth of the damage in the worst point was 3.4 mm for a width of around 40 mm. Ansaldo Energia performed the rotor repair in a local workshop on line during the major overhaul carried out in 2023.

On the right side of the Figure 6 the most interesting phases of the repair are represented:

- machining of the damaged area for welding preparation;
- SAW welding;
- local monitored PWHT;
- NDTs;
- final machining to restore the original geometry.

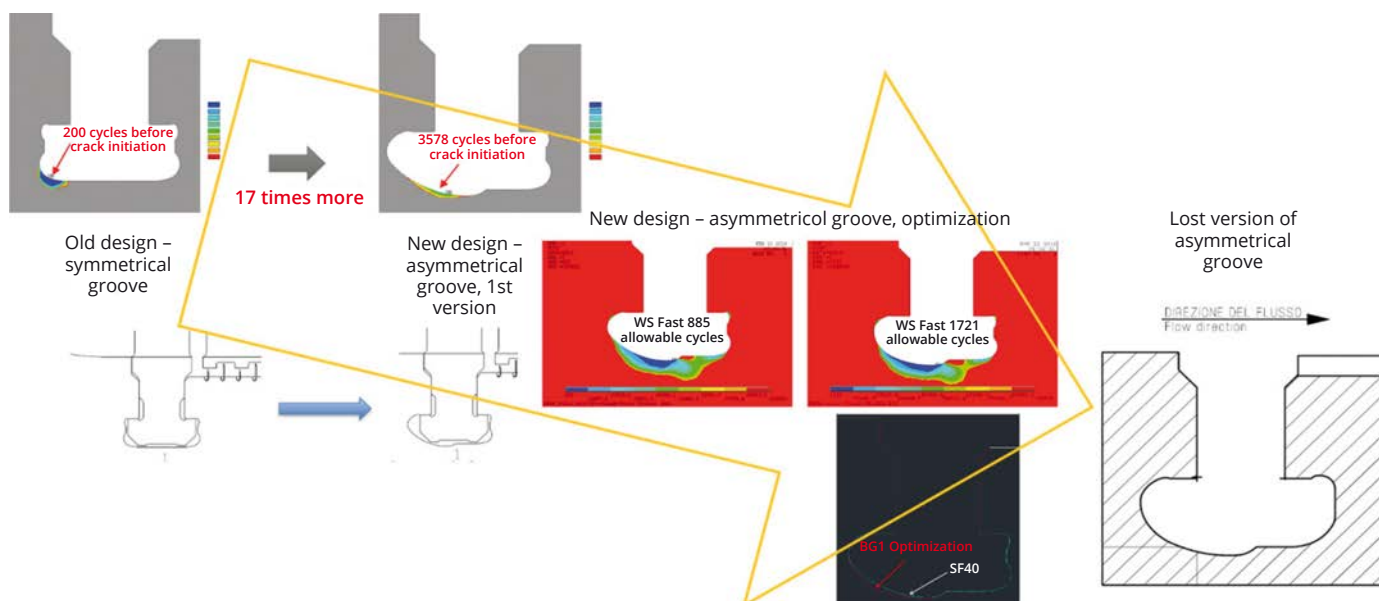
Fig. 8. 1st stage blades groove history and evolution.

In Figure 8 the 1st stage blades groove history is summarized based on Finite Element Method simulations results.

Therefore, in case of symmetrical groove design, it is mandatory to rework the groove at first useful occasion to apply the last asymmetrical groove design. In case of an already asymmetrical groove, but of the first design, an inspection and/or preventive reworking could be necessary, based on unit history.

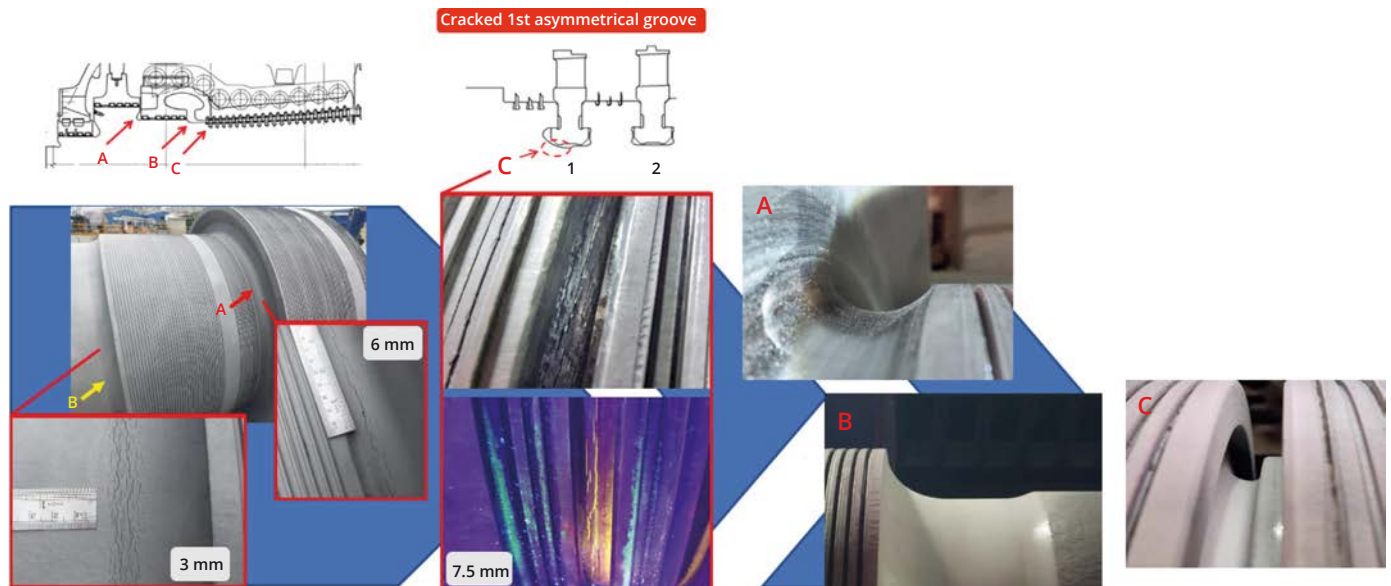
Fig. 9. Single flow cracked rotor, case study.

A relevant case study (one of the worst, but we had many cases of cracked rotors in the last years), can be seen in Figure 9, involving a single flow HP rotor of Ansaldo 94MW reaction type turbine. During the last overhaul several cracks in different places with different depth were found, and not only on the rotor fillets, but also in the groove of the first stage blades. This rotor in the past was bowed due to water ingress and it was performed straightening by hot spotting and stress relief heat treatment. So with this history and these extensive cracks it was clear that the material was at the end of its life. The solution was to supply and install new rotor, but based on new rotor unavailability it was defined a mitigation plan to allow temporary operation waiting for the new rotor. The mitigation plan basically consisted on:

- cracks removal, new profiles definition and recountouring, which was performed on site online with portable lathe;
- modification of start-up curves;

- vibration data monitoring, especially in terms of modification of 1st critical speed, which based on our experience is one of the most important parameter to be monitored in order to understand if there is an advanced stage crack not uniformly distributed along the circumference in the rotor body (it is the last signal to prevent rotor failure during operation)
